State of California & The Resources Agency
 DEPARTMENT OF PARKS AND RECREATION
PRIMARY RECORD

Page 1 of 1 *Resource Name or #: (Assigned by recorder) Willow Glen Trestle over the Los Gatos Creek

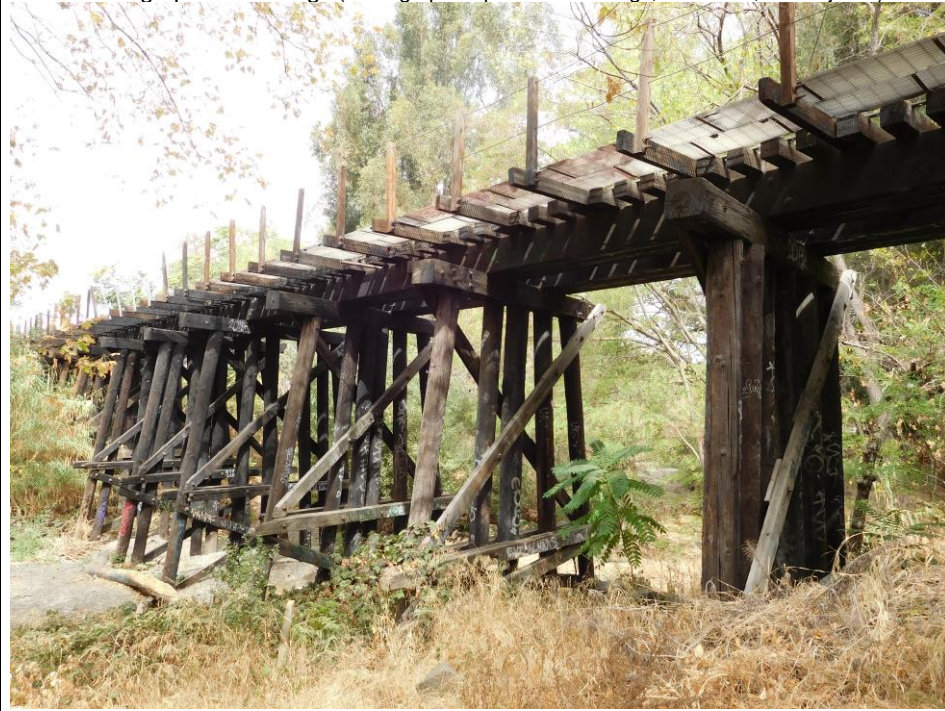
P5a. Photograph or Drawing (Photograph required for buildings, structures, and objects.)

The Willow Glen Trestle (the Trestle) is located on the former Western Pacific Railroad right-of-way and crosses Los Gatos Creek between Coe Avenue and Lonus Street, in the residential community of Willow Glen, San Jose, California. The Trestle an open-deck pile-supported trestle that has an overall span length of 210.5 feet and is approximately 25 feet high at its tallest point. Constructed by the Western Pacific Railroad in 1922, the subject engineering structure is supported by two timber pile abutments and thirteen timber pile bents. The bents range in size and geometry at each location, but the longitudinal spacing of the bents is constant at approximately 15 feet. The bents have a skew angle of approximately 9.5 degrees. The Trestle communicates sufficient historic integrity to support Criterion 1, with all timber elements of the superstructure and substructure extant. Deck modifications, including removal of the rails, rail tie plates and replacement of the deck safety rail have compromised some integrity of design, materials and feeling.

P5b. Description of Photo: (view, date) Southwest elevation, camera facing north, 9/27/15: see the photographic records in the Continuation Form
