Feasibility Study

Three Creeks Trail Railroad Trestle at Los Gatos Creek

Prepared for
City of San Jose

October 08, 2012

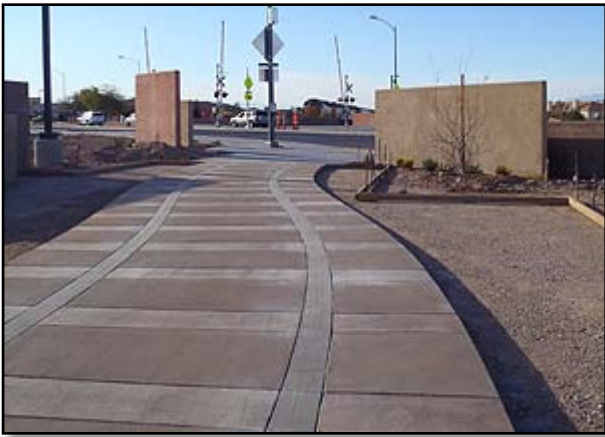
Figure 1: Concrete Stain Example

If visual appearance is a concern, the concrete deck can be scored and stained to resemble the old railroad tracks for an aesthetically pleasing nod to the past life of the structure. This treatment has been used in other locations where a pedestrian facility has replaced a railroad track. The concrete stain could be something similar to what is shown in **Figure 1**.
