Appendix A
Three Creeks Trail Pedestrian Bridge Project
Scoping Report and Materials

Scoping Report Environmental Impact Report on the Three Creeks Trail Pedestrian Bridge Project

Prepared for
City of San José

November 2014

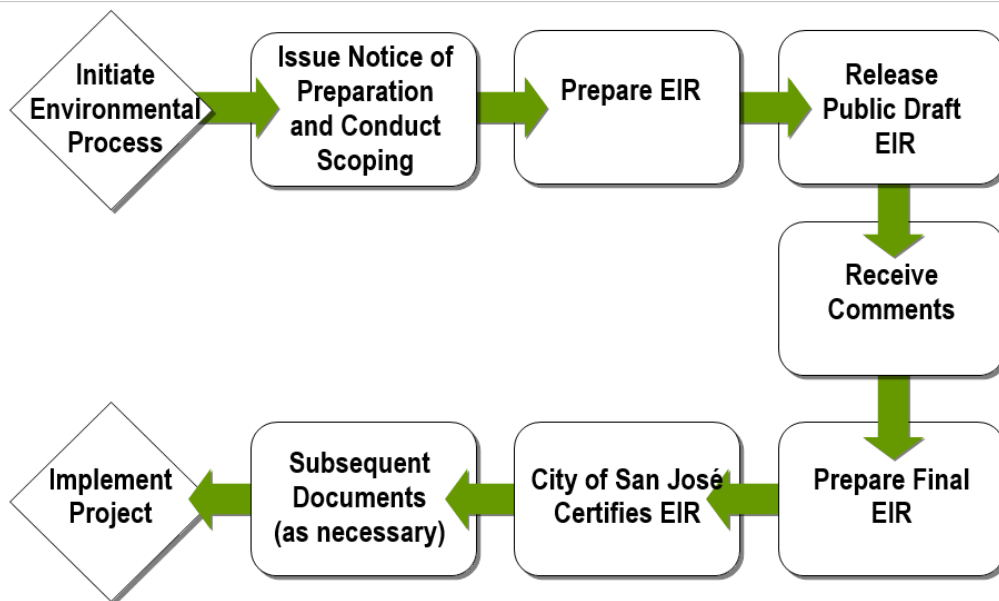
FIGURE 1-1
CEQA Process

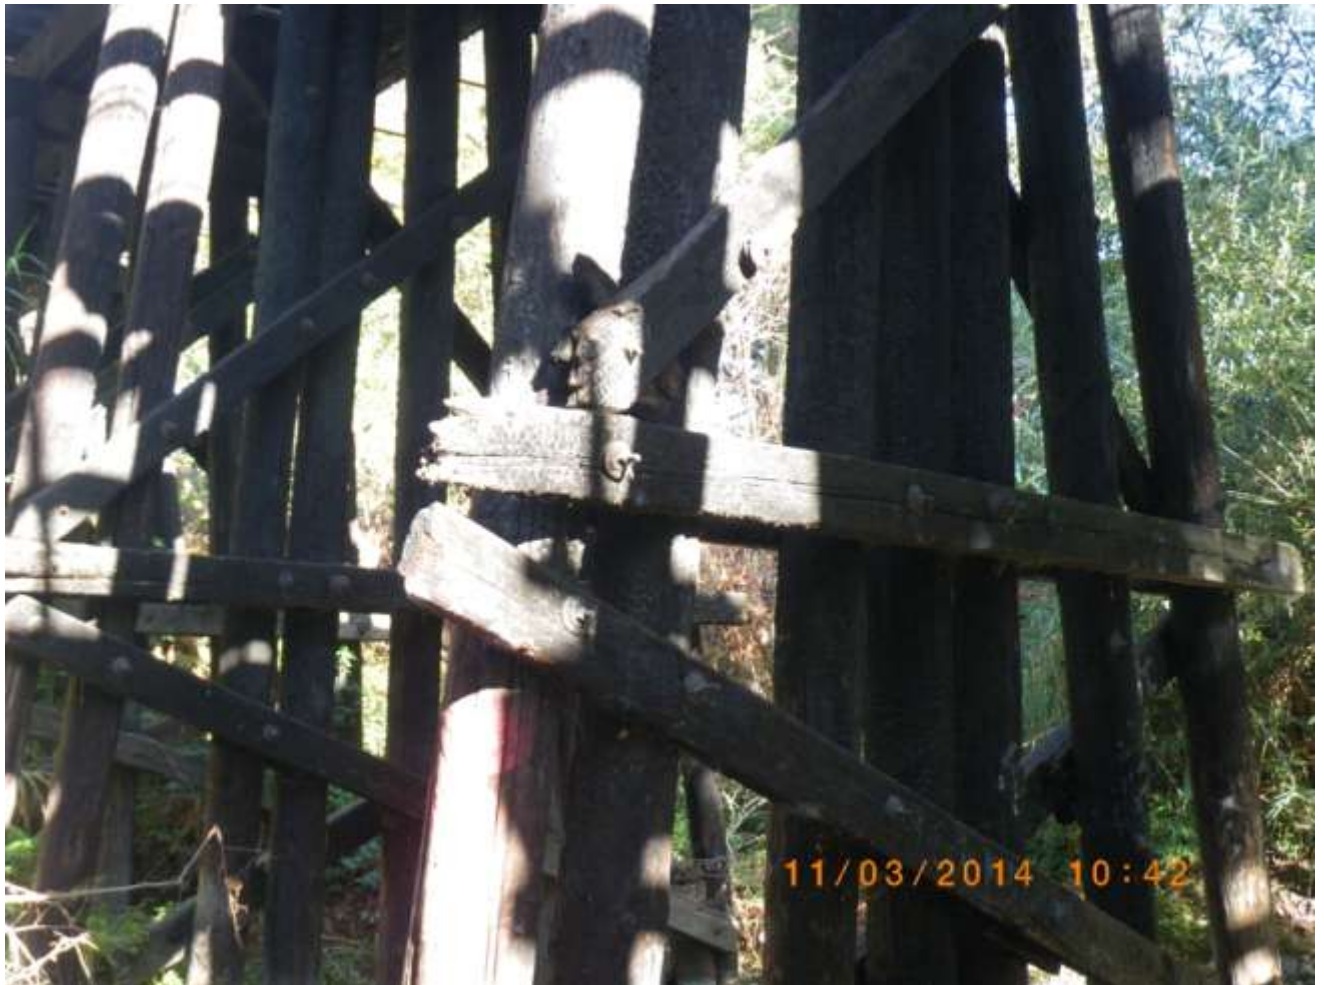
Photo #8. Weathered and splintering pilings on railroad trestle in disrepair. 3 November 2014

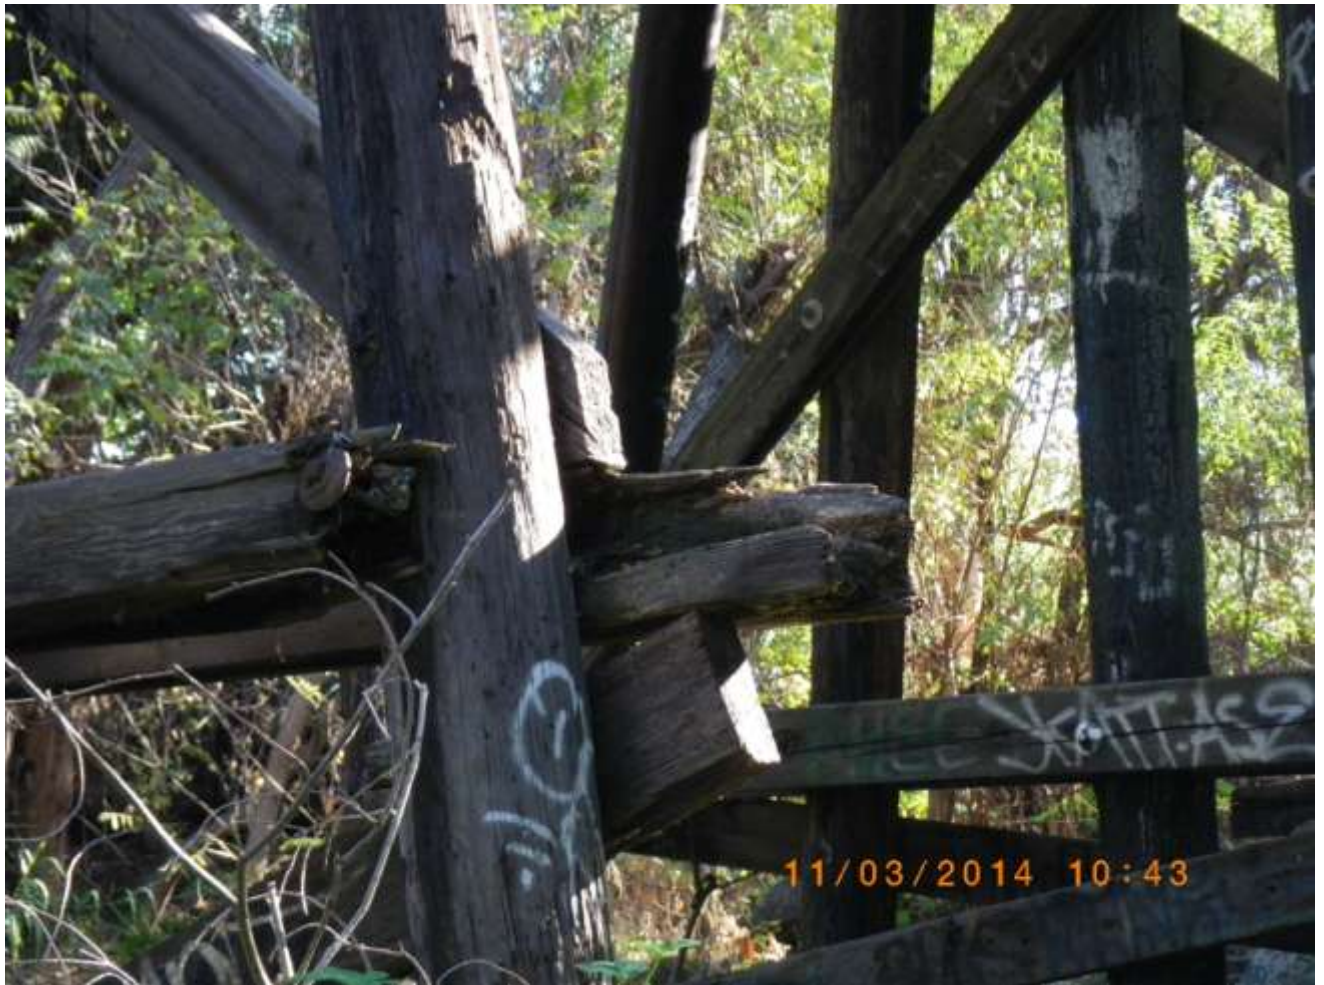
Photo #9. Weathered and splintering pilings on railroad trestle in disrepair. 3 November 2014

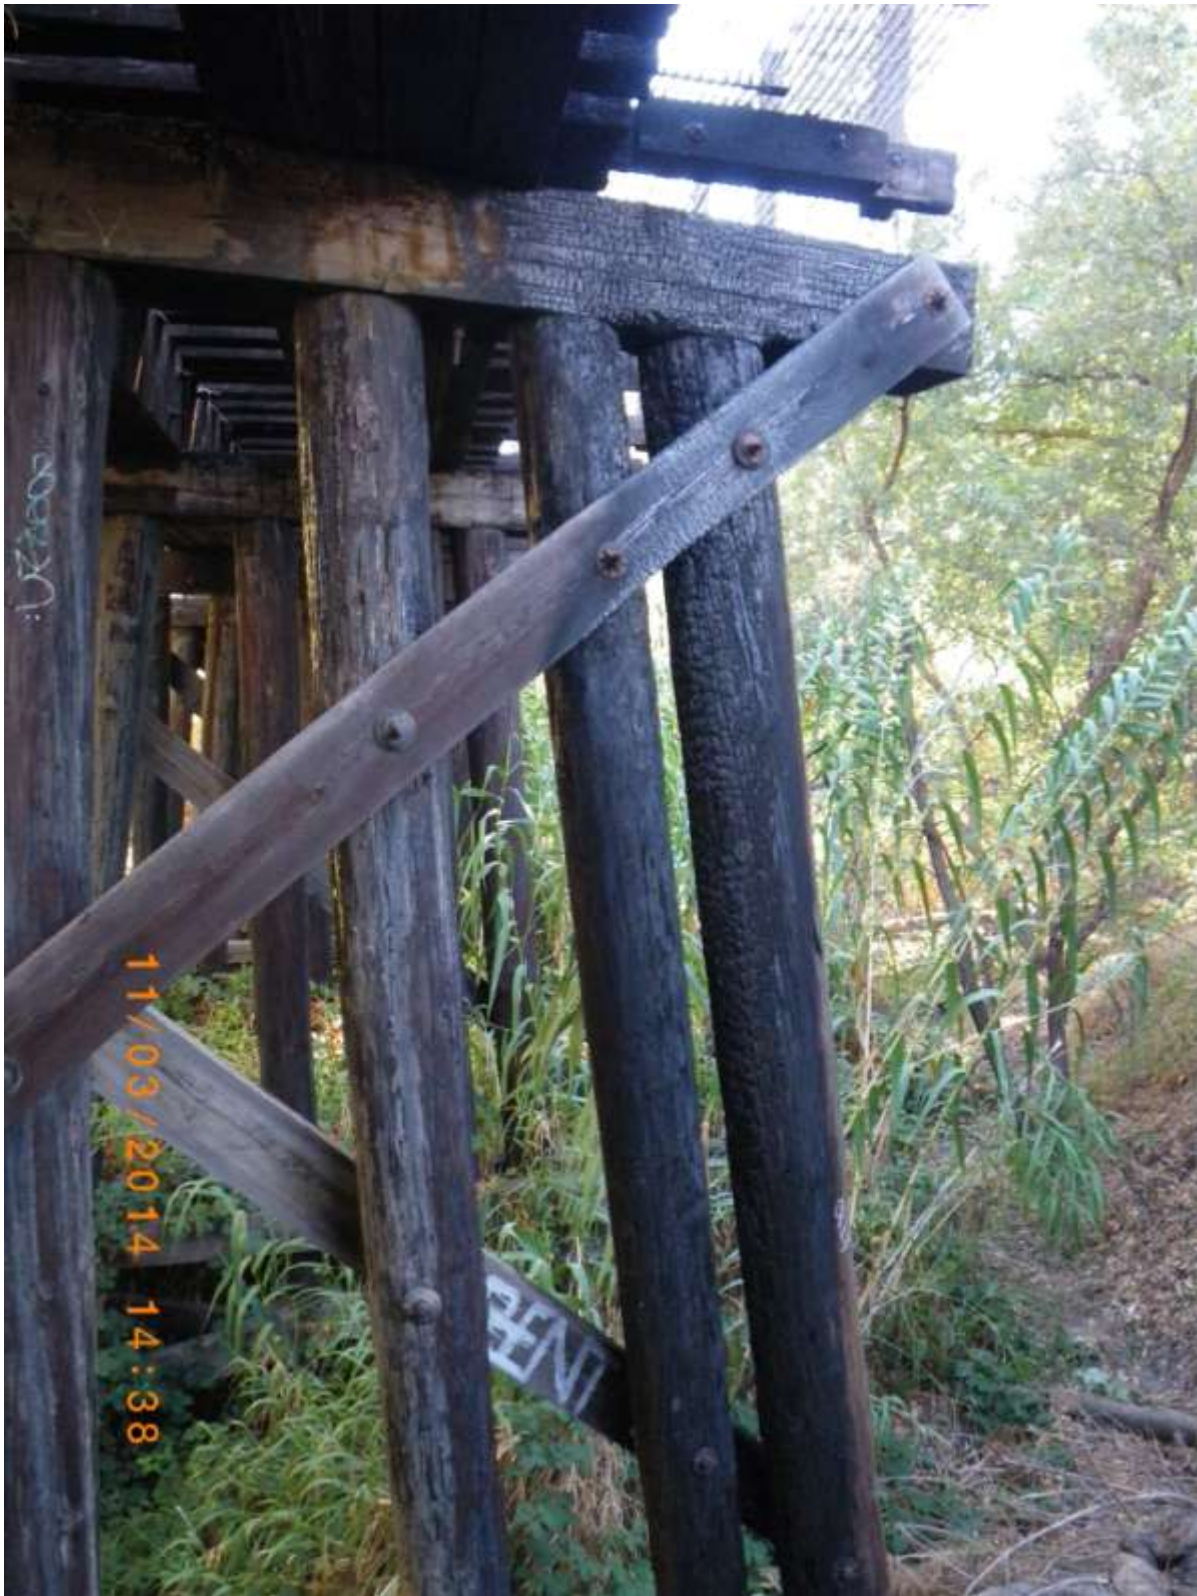
Photo #10. Charred pilings on railroad trestle, north side. 3 November 2014

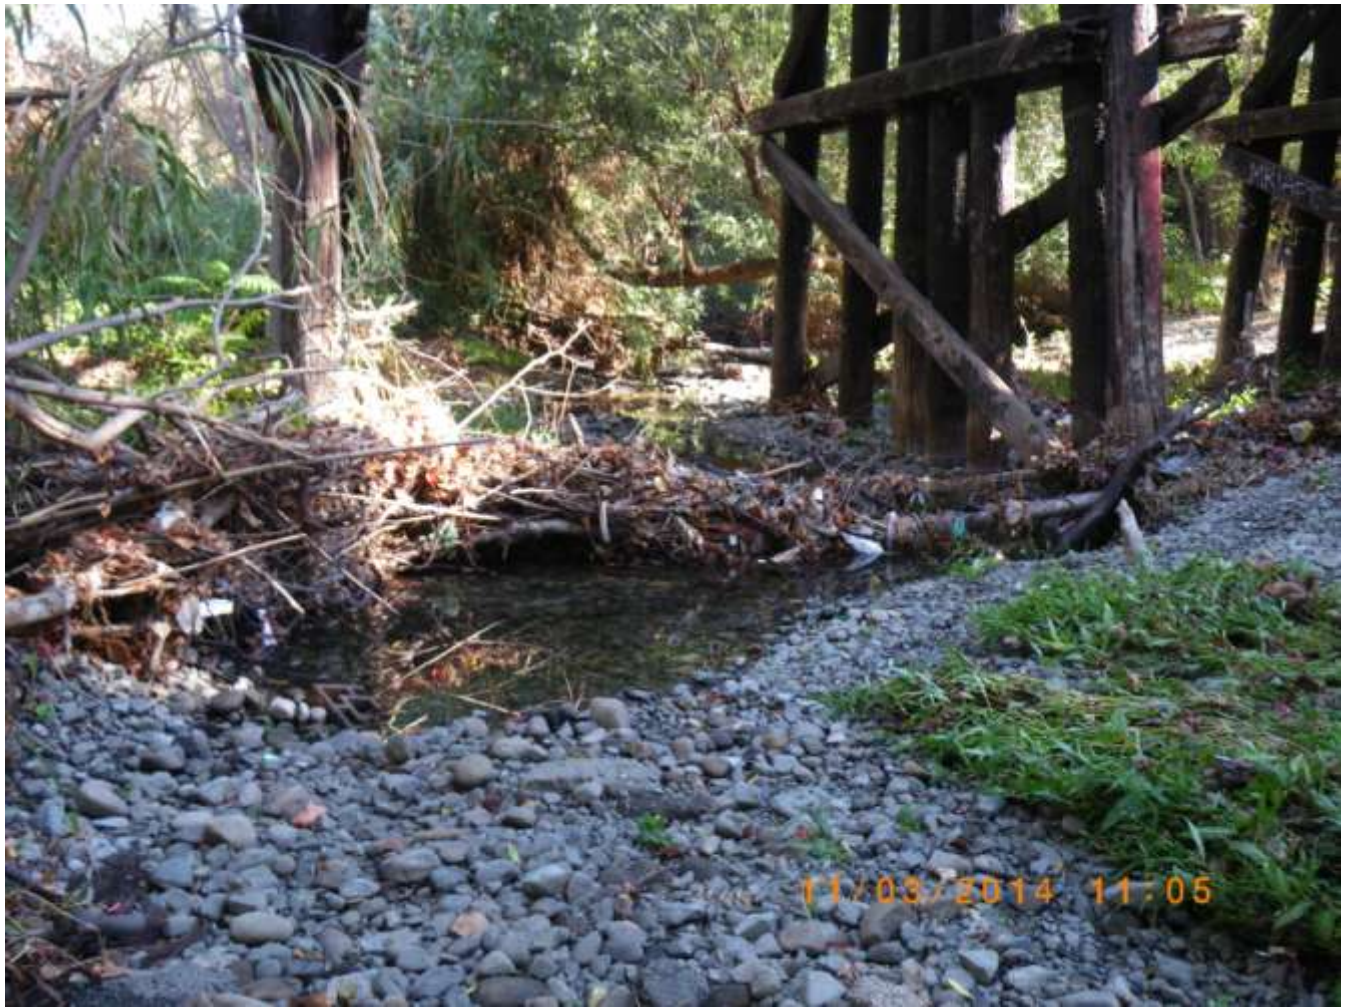
Photo #11. Woody debris collected on railroad trestle pier. 3 November 2014

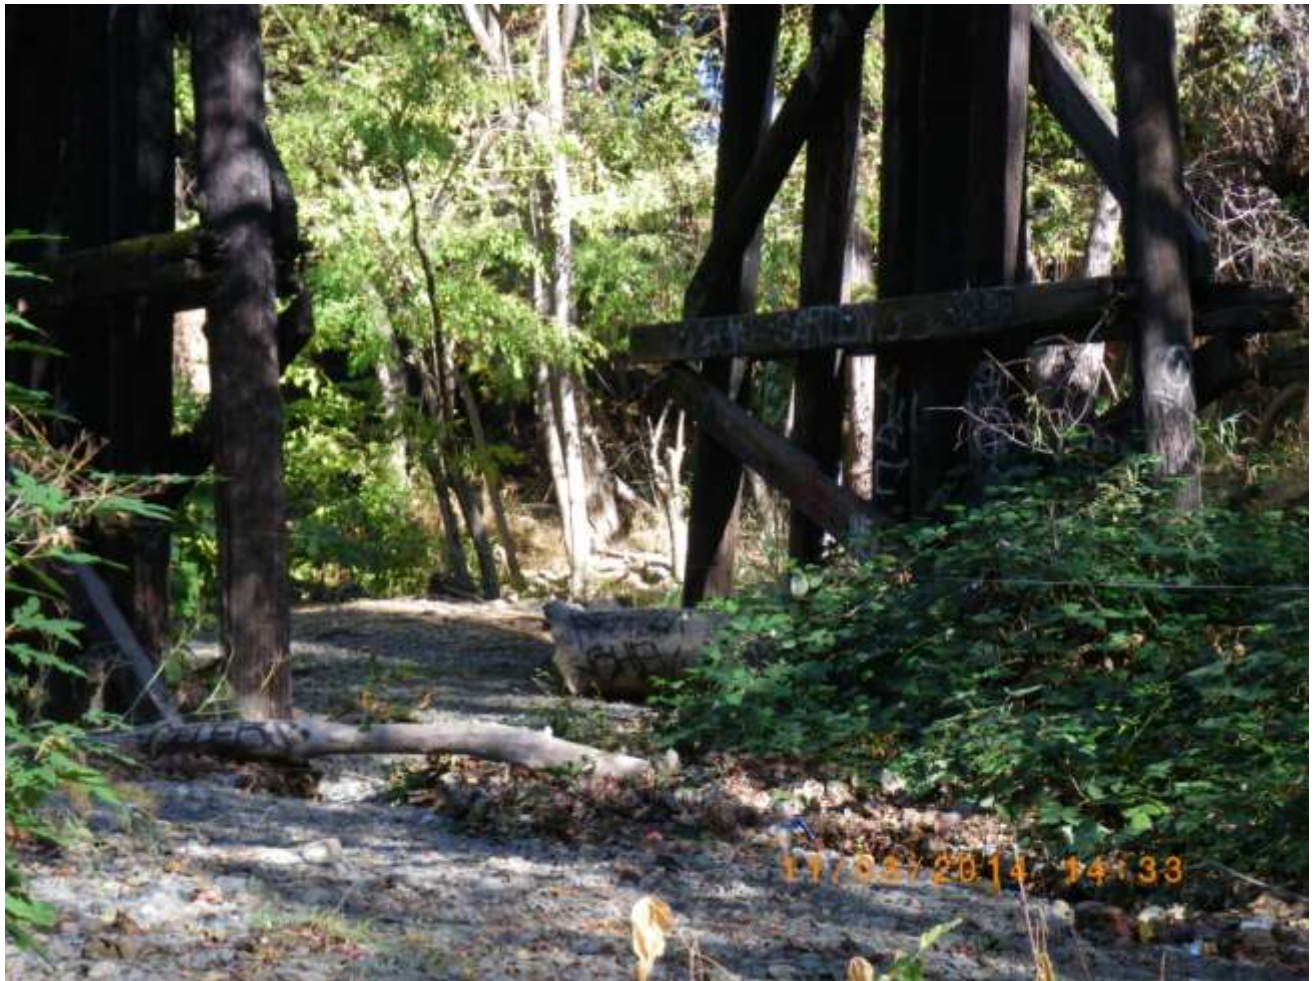
Photo #13. Large wood collected on railroad trestle pier within bankfull channel. 3 November 2014

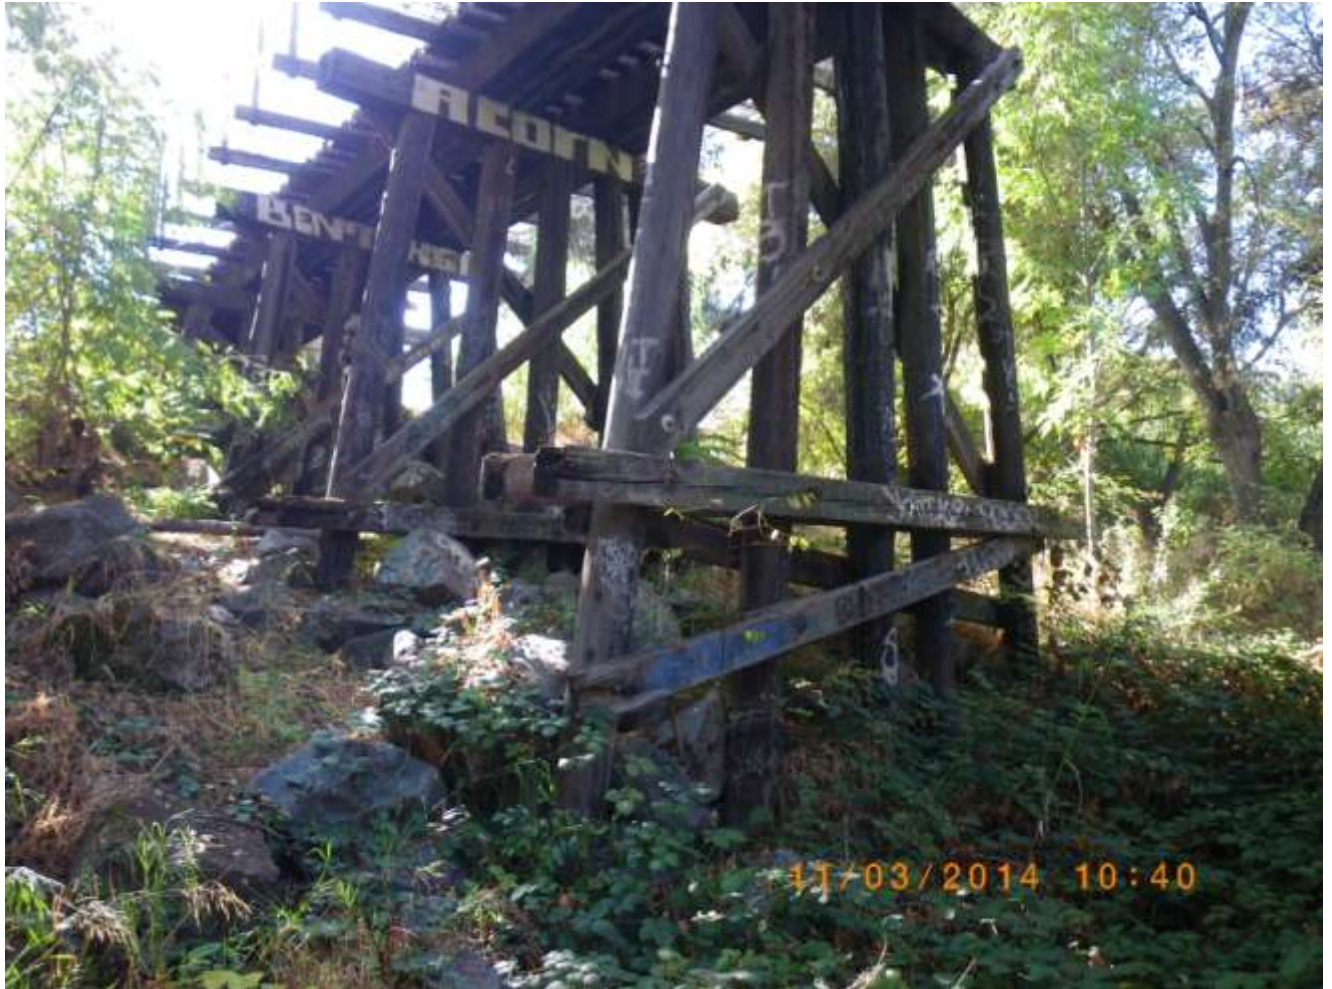
Photo #14. Riprap under railroad trestle (weathered pilings), south side. 3 November 2014

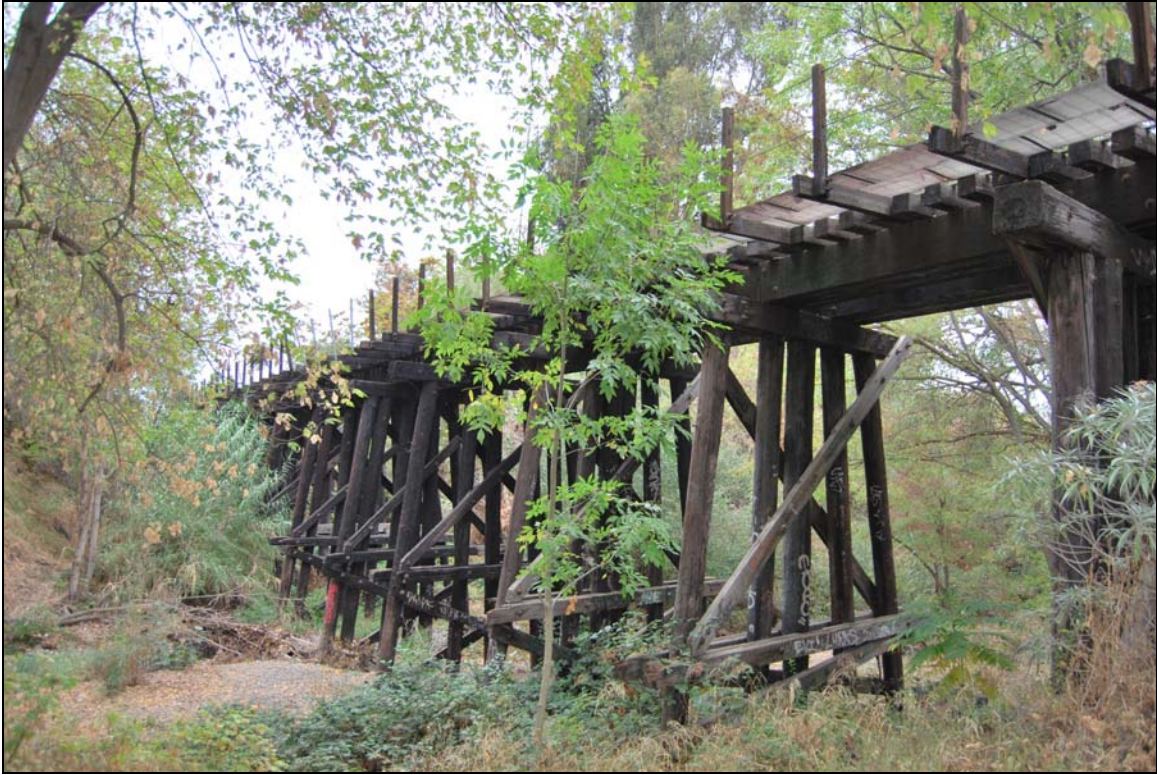
Figure 6: Trestle understructure, view to the north

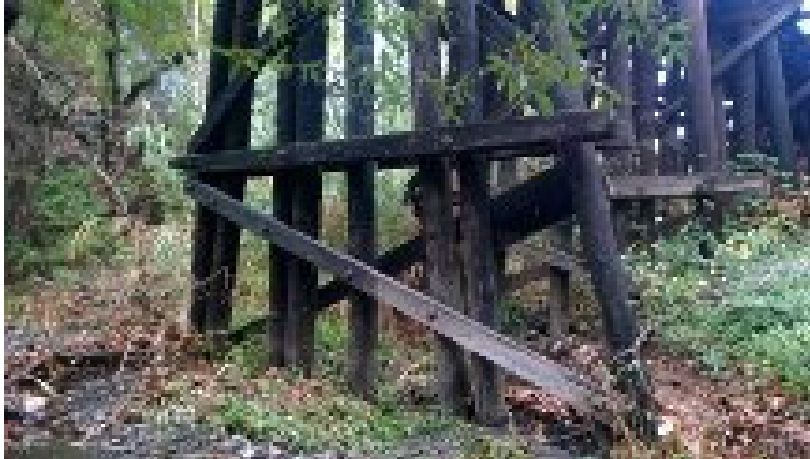
The manner in which the number of bents varies suggests strongly that the bridge was modified with the use of paired piles, or soldier piles, to take the stress from deteriorated piles. In every case in which there are more than six piles, the additional piles are paired with heavily deteriorated piles. This doubling of piles is illustrated below.

Pile bents showing doubled piles, from Los Gatos Creek bed

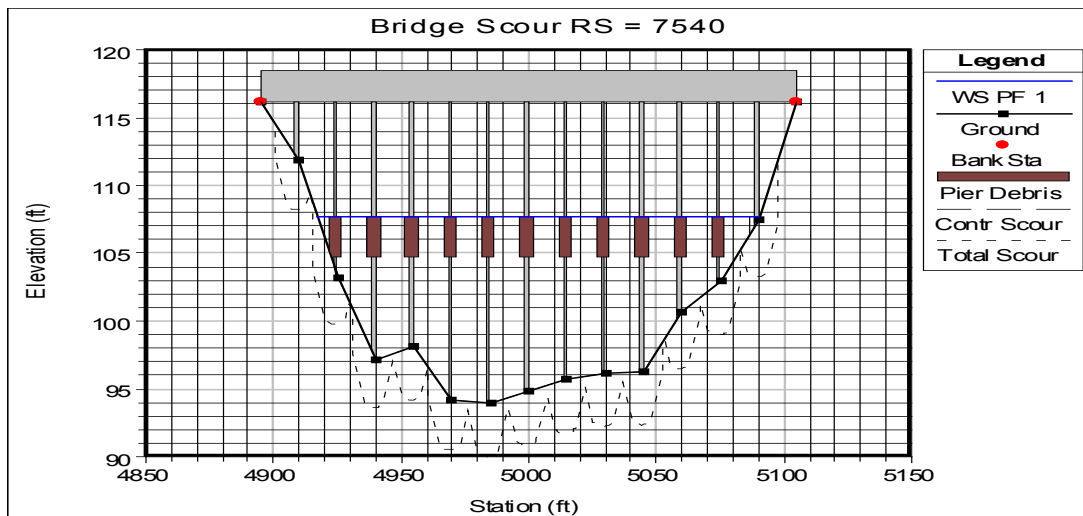
Figure 8: Cross-Section from HEC-RAS Model Illustrating Pier Scour Conditions for 100-year Flood Event
